aQuatite™

where does the water go?

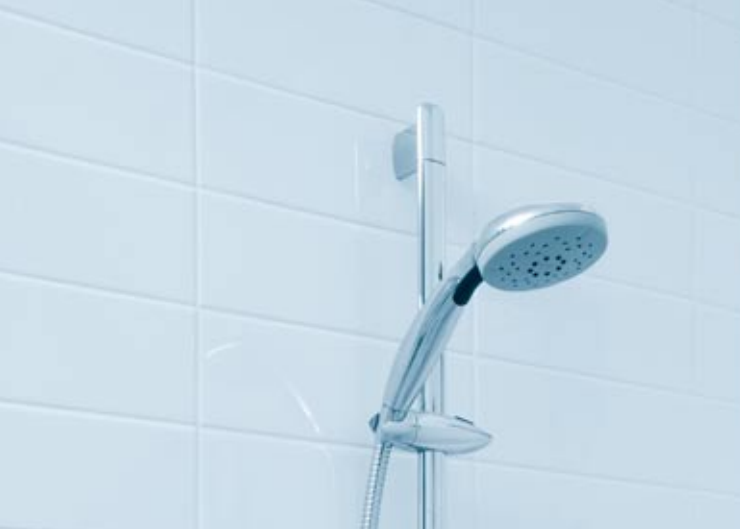
This shower is built without Aquatite wet wall protection.

When a shower is built, two holes are made in the wall for the mixer and the shower outlet. This creates an opportunity for water to make its way into the wall cavity.

Any hardware or plumbing failure inside the wall also allows water to enter the wall cavity with no means of drying or drainage.

This can cause the wall to rot and grow mould which is both unpleasant and hazardous to your health.

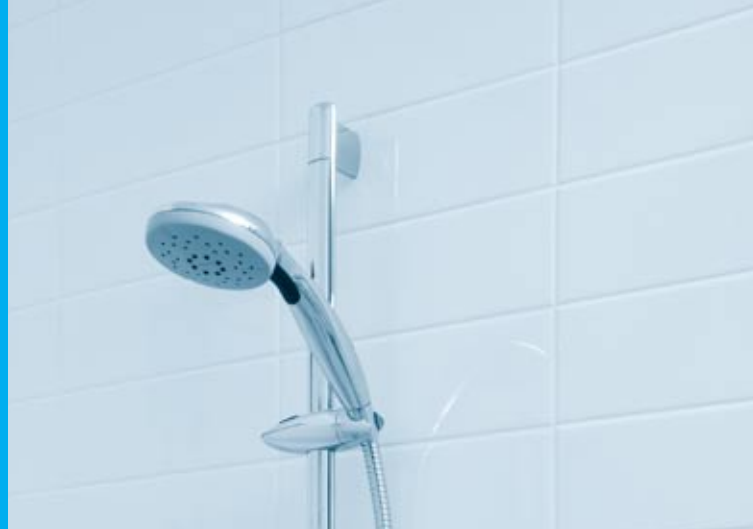
**This shower is built with
Aquatite wet wall protection.**

In this case, the shower wall is protected with two **Wetwall Caddy™** devices.

These devices protect your wall cavity from moisture entering through the penetrations created for the mixer and outlet. They also prevent damage caused by leaks due to plumbing or hardware failure at these points.

A Wetwall Caddy achieves this protection by:

- **Retaining.** A Wetwall Caddy catches and contains the water, preventing it from entering the wall cavity.
- **Diverting.** An acute failure will fill the Wetwall Caddy to a threshold at which point additional water is diverted back out of the device and down the outside face of the wall. This will alert you to a failure which can then be serviced at minimal cost.

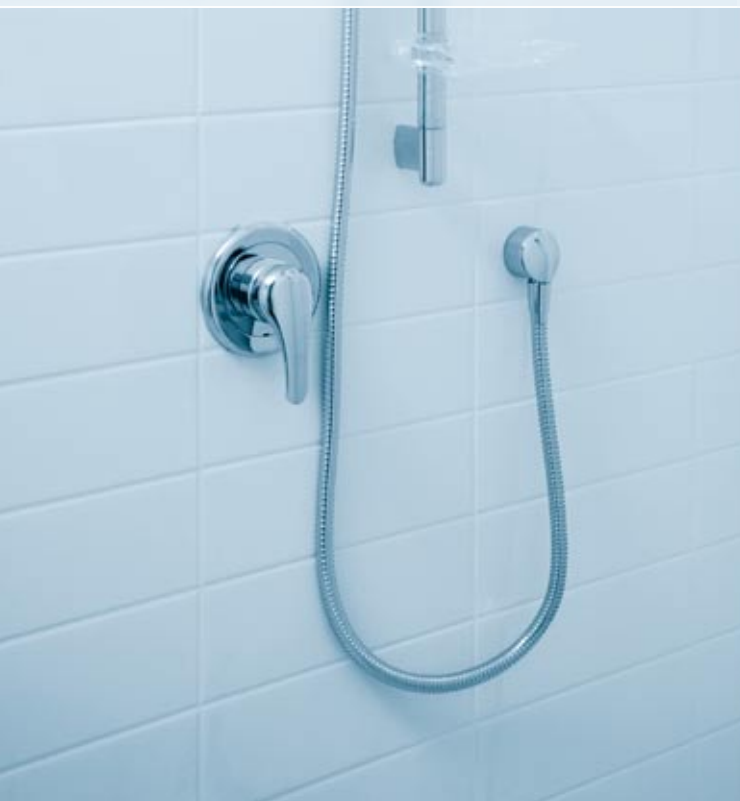
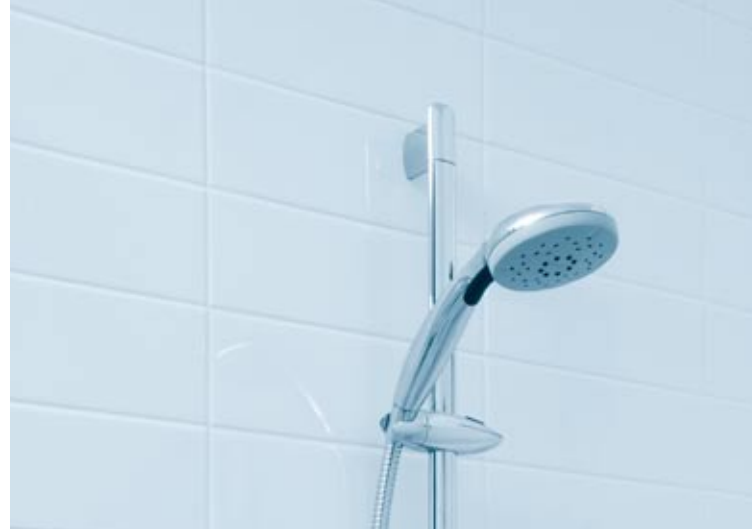
STANDARD

Due to lack of visibility, a failure can go undetected for months or even years.
